**A CHARACTERIZATION AND ANALYSIS
OF THE FLOOR PLASTERS
FROM THE ACROPOLIS AT COPAN, HONDURAS**

A THESIS

**The Graduate Program in Historic Preservation in
Partial Fulfillment of the Requirements for the Degree of the Master of Science**

1998

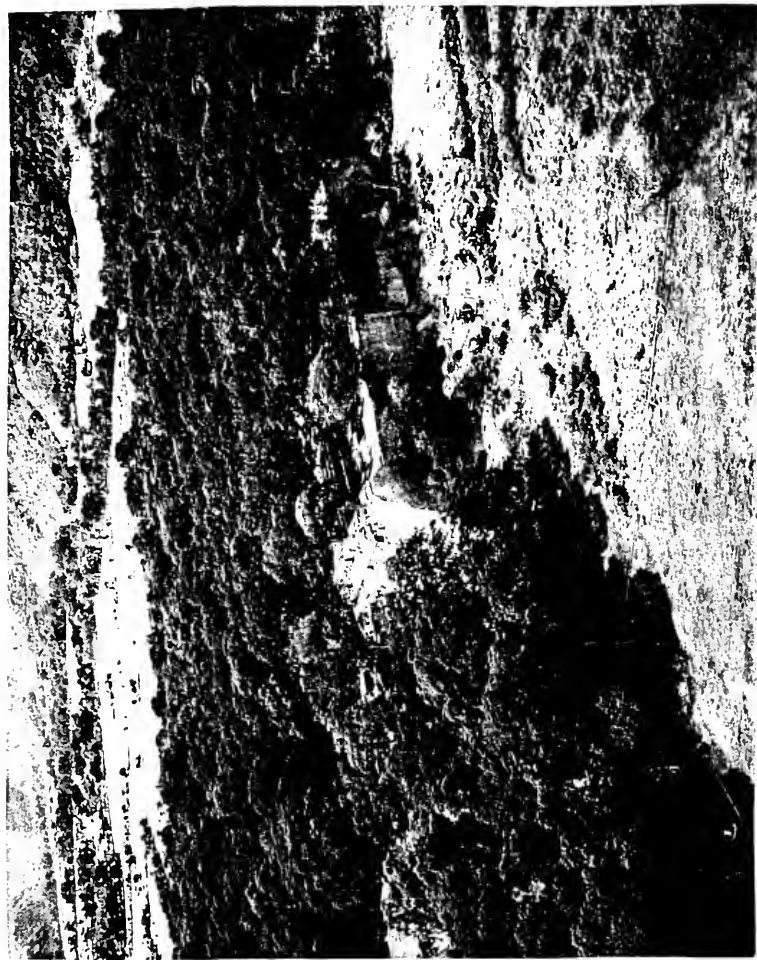
Figure 6. Corte of the eastern edge of the Copan Acropolis. From Giuseppe Orefici. *I Maya di Copan*. (Milan: Skira, 1997). 63)

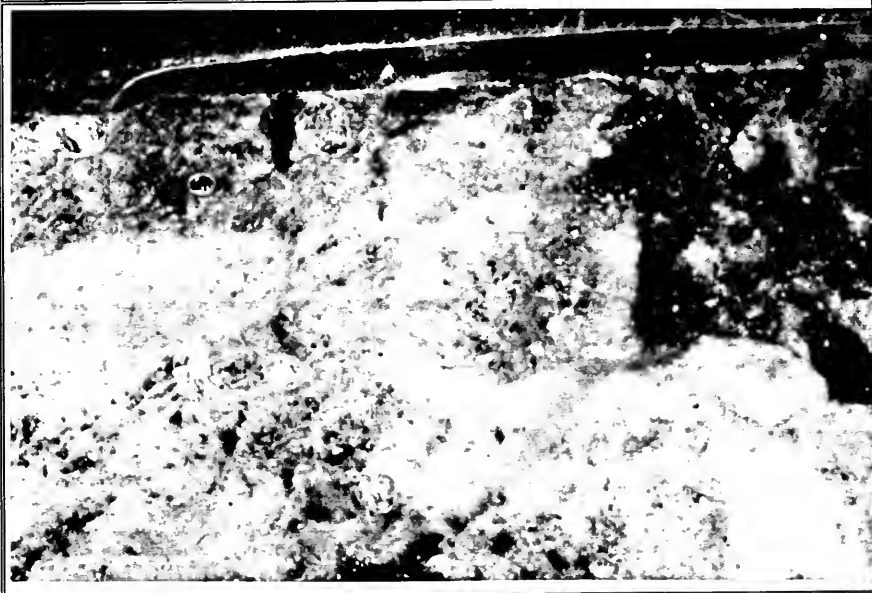
CROSS SECTION EXAMINATION		SAMPLE: 37
Floor Name: Chinchilla		
Sample Location: Northeast Court Group, below Loro.		
Division: 6	Date: A.D. 250 - 420	Magnification: 5x
<p>General Description:</p> <p>Sample consists of an earthen plaster. Poorly sorted aggregates, consisting of lime-based particles, volcanic tuff and sand which varies in color (brown and red) ranging from fine to medium sizes, between 0.1 – 0.7 mm. The majority of particles exhibit subrounded and subangular shapes, with some irregular surfaces. Cracking occurs in the middle of the sample. No distinct layers are discernible.</p>

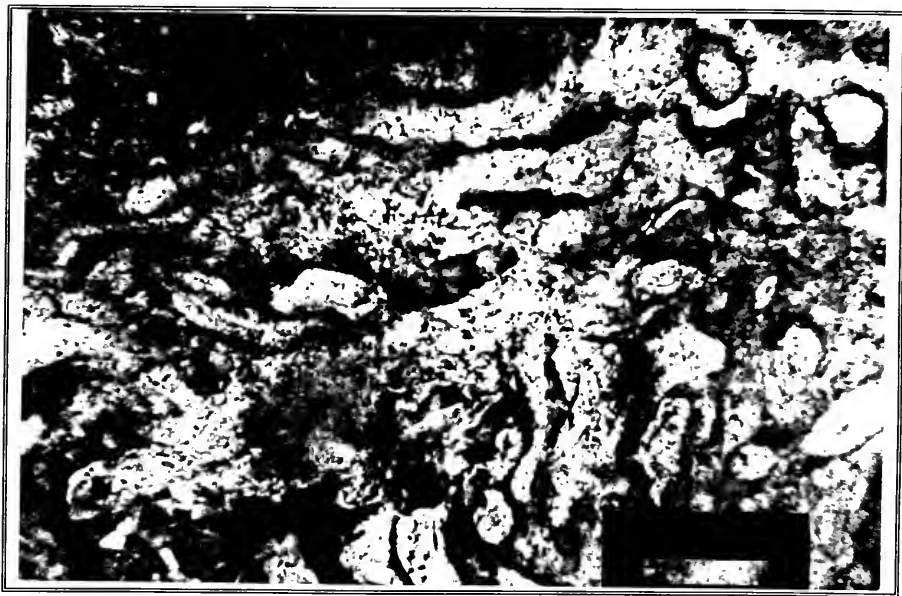
Photomicrograph of thin section #26 (Division 5) at 25x under transmitted light and crossed polars.

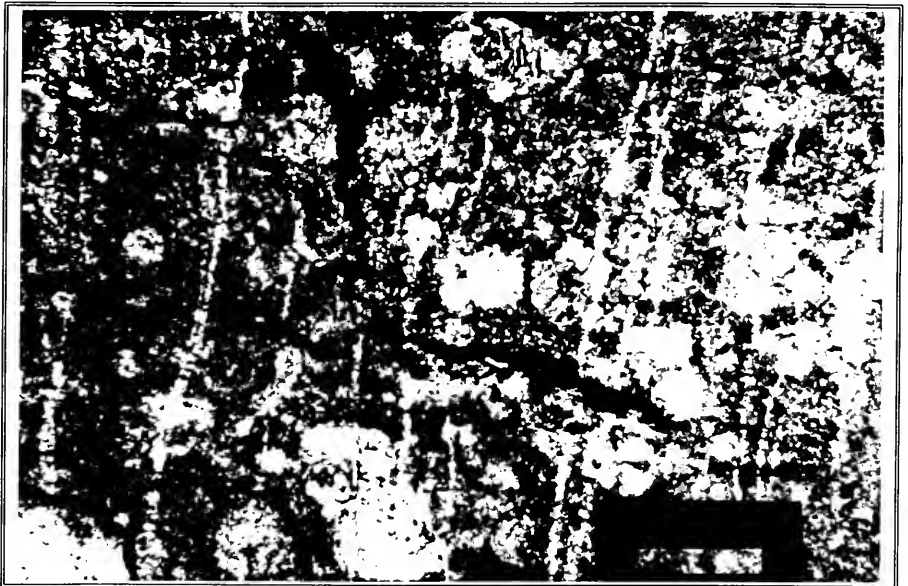
Photomicrograph of thin section #95 (Division 5) at 100x under transmitted light and crossed polars.

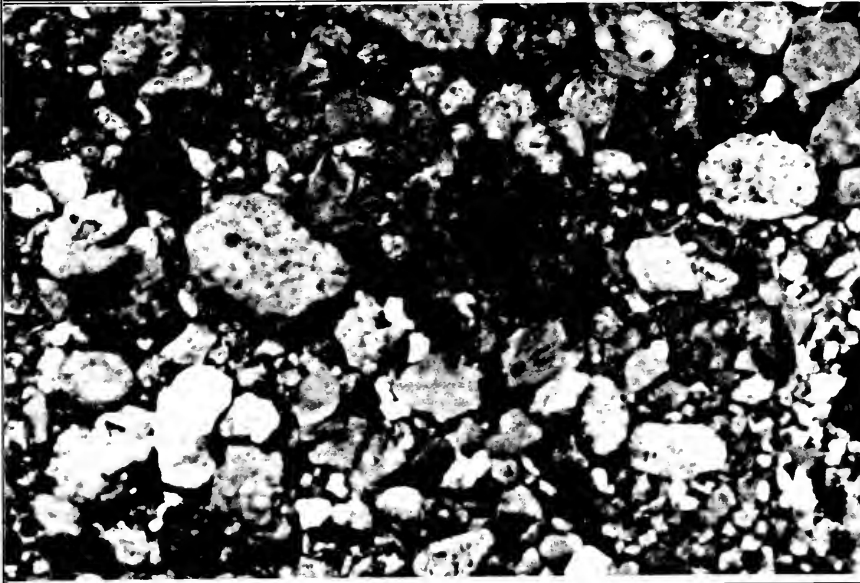
COARSE FRACTION EXAMINATION		SAMPLE #:27	
Floor Name: Mot Mot			
Sample Location: Northeast Court Group, north of Tartan.			
Division: 5, MAS 7	Date: A.D. 460 - 470	Magnification: 8.75 x	
Shapes: Round, subround, and subangular.			
Colors: Tan, pink, orange, translucent, beige, gray, and rust.			
SIEVE ANALYSIS			
Sieve #	Size	Weight (grams)	% Retained
8	2.36 mm	1.86	53.44
16	1.18 mm	0.63	18.10
30	600 µm	0.27	7.75
50	300 µm	0.24	6.89
100	150 µm	0.18	5.17
200	75 µm	0.18	5.17
Pan		0.12	3.44

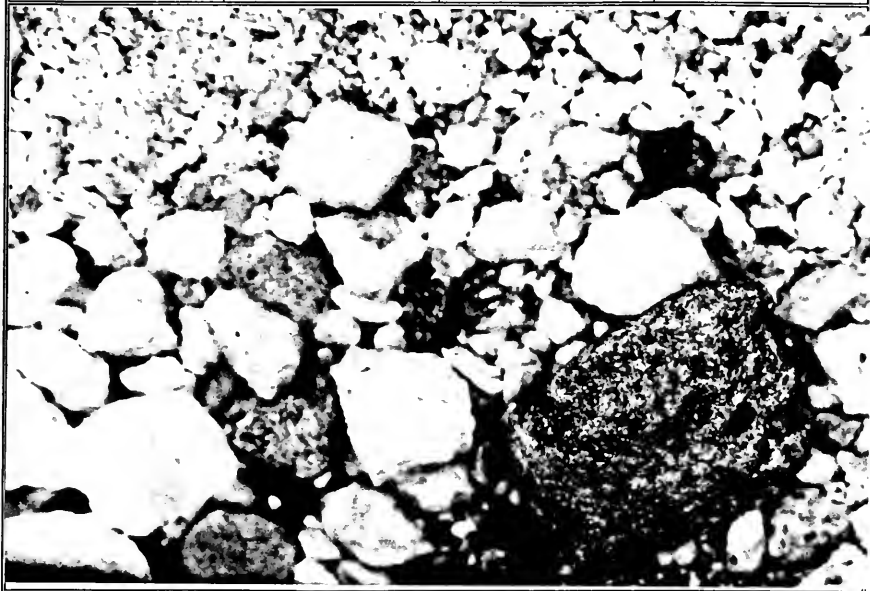
COARSE FRACTION EXAMINATION		SAMPLE #: 61	
Floor Name: Chachalaca Floor #3			
Sample Location: Northeast Court Group, 3 rd plaza surface above top of Indigo.			
Division: 2	Date: A.D. 540 - 650	Magnification: 3.75x	
Shapes: Subround, and subangular.			
Colors: Green, yellow, and black.			
SIEVE ANALYSIS			
Sieve #	Size	Weight (grams)	% Retained
8	2.36 mm	2.19	45.91
16	1.18 mm	0.84	17.61
30	600 µm	0	0
50	300 µm	0	0
100	150 µm	1.42	29.56
200	75 µm	0.27	5.66
Pan		0.06	1.25

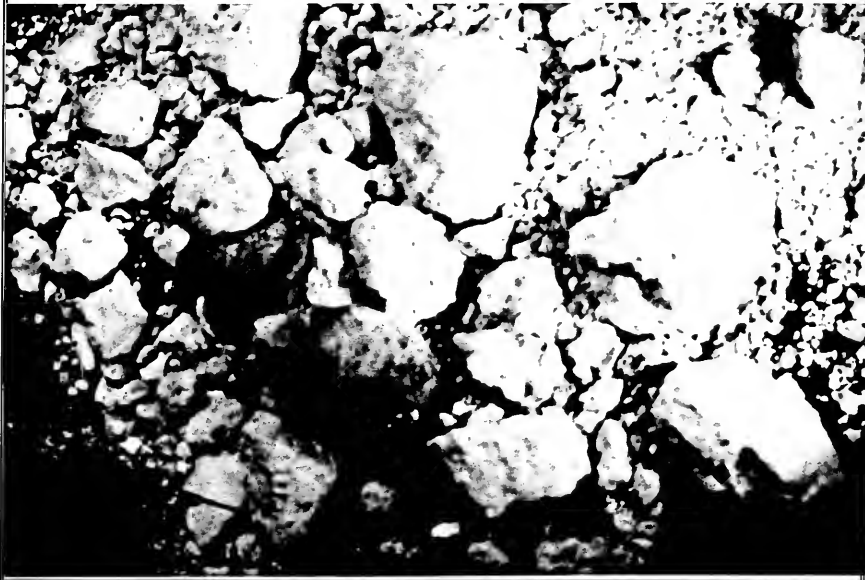
COARSE FRACTION EXAMINATION		SAMPLE #: 62	
Floor Name: Chachalaca Floor #4			
Sample Location: Northeast Court Group, 2nd plaza surface above top of Indigo.			
Division: 2		Date: A.D. 540 - 650	Magnification: 5x
Shapes: Subround, and subangular.			
Colors: Green, yellow, tan, rust, brown, gray, and pink.			
SIEVE ANALYSIS			
Sieve #	Size	Weight (grams)	% Retained
8	2.36 mm	0.16	6.25
16	1.18 mm	0.4	15.62
30	600 μm	0.28	10.94
50	300 μm	0.36	14.06
100	150 μm	0.56	21.87
200	75 μm	0.66	25.78
Pan		0.14	5.47

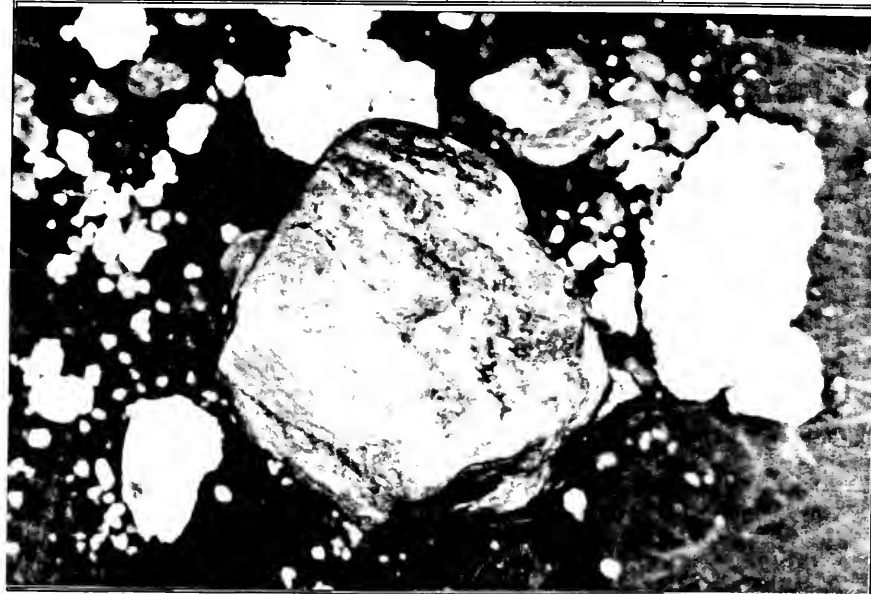
COARSE FRACTION EXAMINATION		SAMPLE #: 82	
Floor Name: Xox			
Sample Location: MAS, runs under Acatan, abuts north side of Cedro.			
Division: 5, MAS 9	Date: A.D. 440 - 450	Magnification: 7.5x	
Shapes: Subround and subangular.			
Colors: Gray, brown, green, and tan.			
SIEVE ANALYSIS			
Sieve #	Size	Weight (grams)	% Retained
8	2.36 mm	0	0
16	1.18 mm	0.08	21
30	600 μ m	0.06	16
50	300 μ m	0.06	16
100	150 μ m	0.12	32
200	75 μ m	0.06	16
Pan		0	0
